Civil Engineering and Development Department (CEDD)

Assignment No. HKI2/4/54 RM(A) (1/15)

**Preliminary Archaeological Impact Assessment for Wan Chai Development
Phase II**

FINAL REPORT

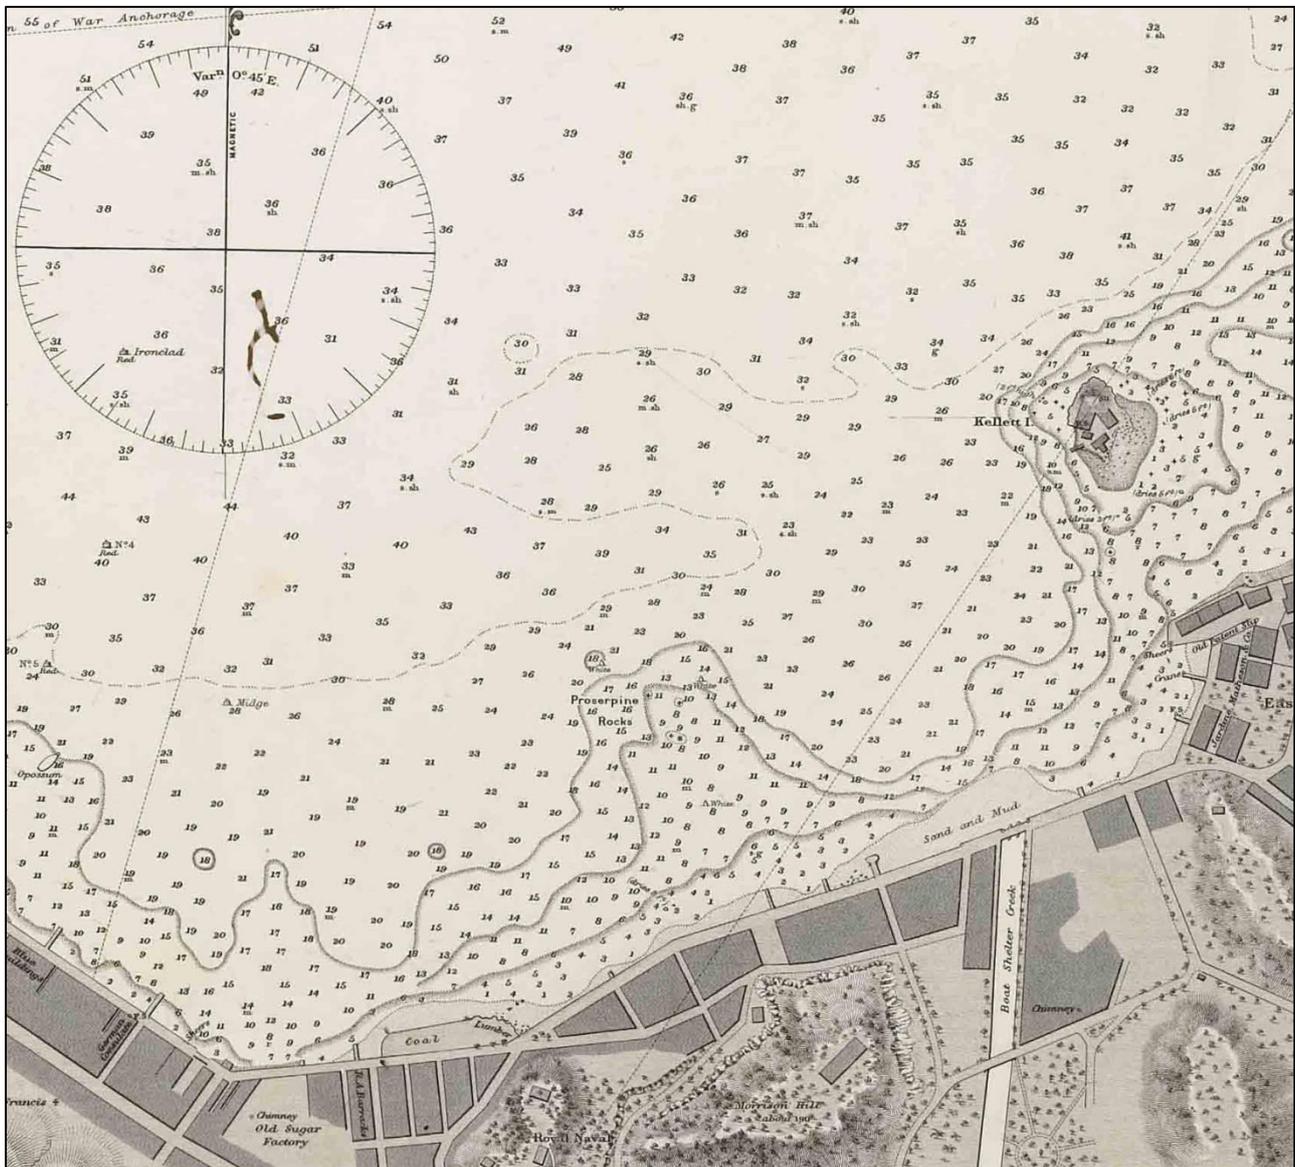
Figure 2: Detail from BA1459 Hong Kong Harbour year 1888. No wreck present at Object location.

According to British Admiralty Chart number 1459, *Hong Kong Harbour* dated 1888 there was no wreck in the general area of interest at that date.

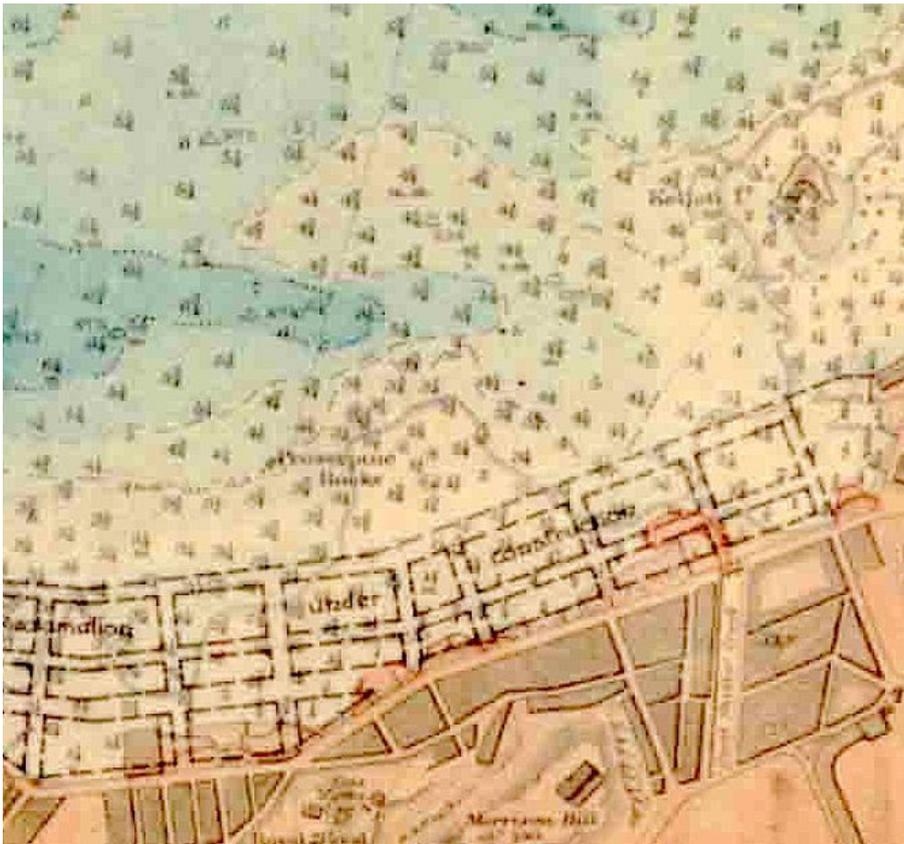
Figure 3: 1921 Chart: Detail from BA3279 Hong Kong Waters. No wreck shown but line of moorings is indicated to the East

According to a composite chart created in 1921 by the Port Engineer, Mr John Duncan, from BA3279. *Hong Kong Waters East* and BA3280 *Hong Kong Waters West*, there is no wreck in the general location in that year either. This strongly indicates the wreck in question was sunk post 1922.

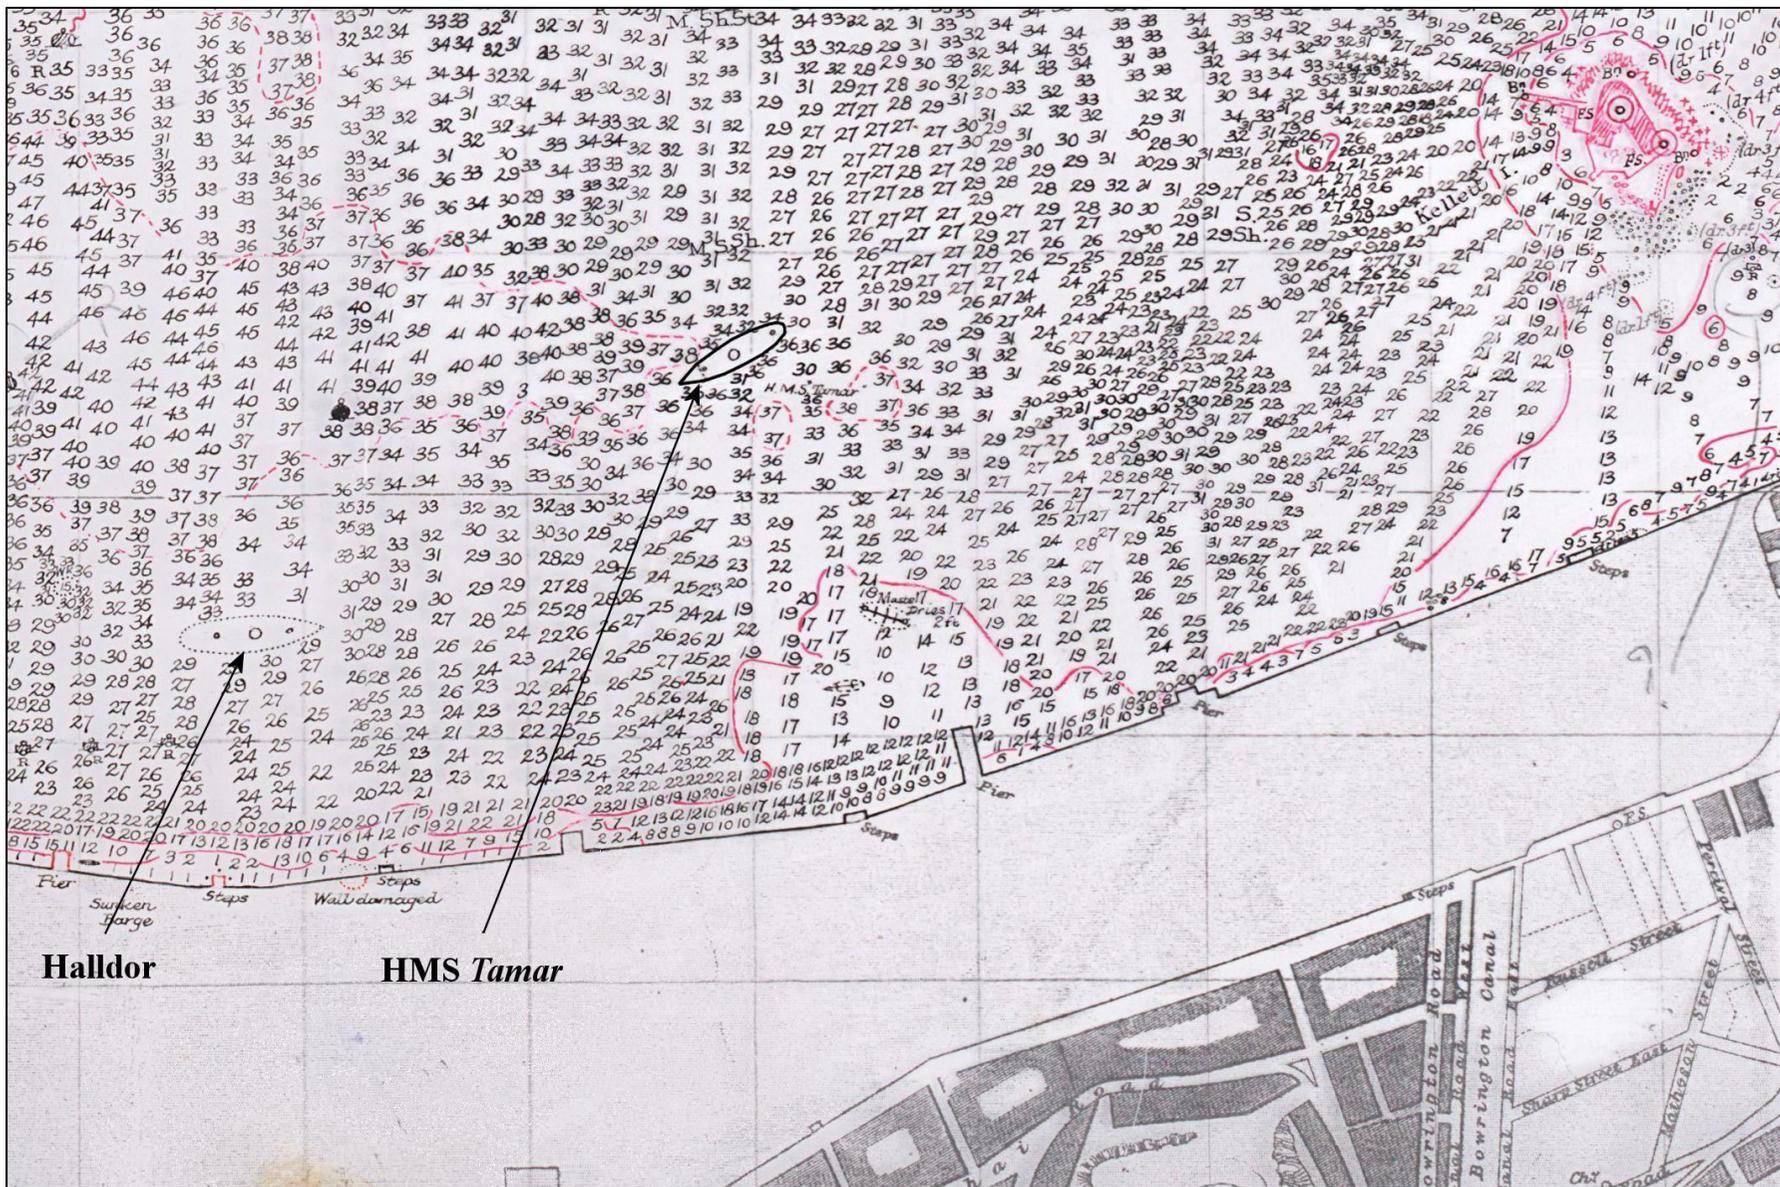
Figure 4: Emergency survey, Hong Kong Harbour, Commander C.W. Sabine RN, HMS Challenger, October-November 1945 (Ref. E7734). Wrecks of HMS Tamar and Halldor both arrowed (note original chart label of “HMS Tamar” to right of wreck). (Chart: HKMM)

In fact a thorough review of newspapers, *Reports of the Harbour Master* and *Reports of the Marine Department* suggested that no wrecks were reported in the immediate environs of the Object up to the beginning of the Pacific War in 1941, but as noted above many ships were sunk between then and 1945. As a precursor to the big post-war clean-up process, between October and November 1945 an emergency survey was conducted by HMS *Challenger* captained by Commander C.W. Sabine RN, which identified the positions of all wrecks in Victoria Harbour. The resulting survey chart (E7734) shows the positions of over 200 wrecks including five in the vicinity of Wan Chai. The wreck of HMS *Tamar* is clearly marked on the 1945 survey chart (Figure 4).

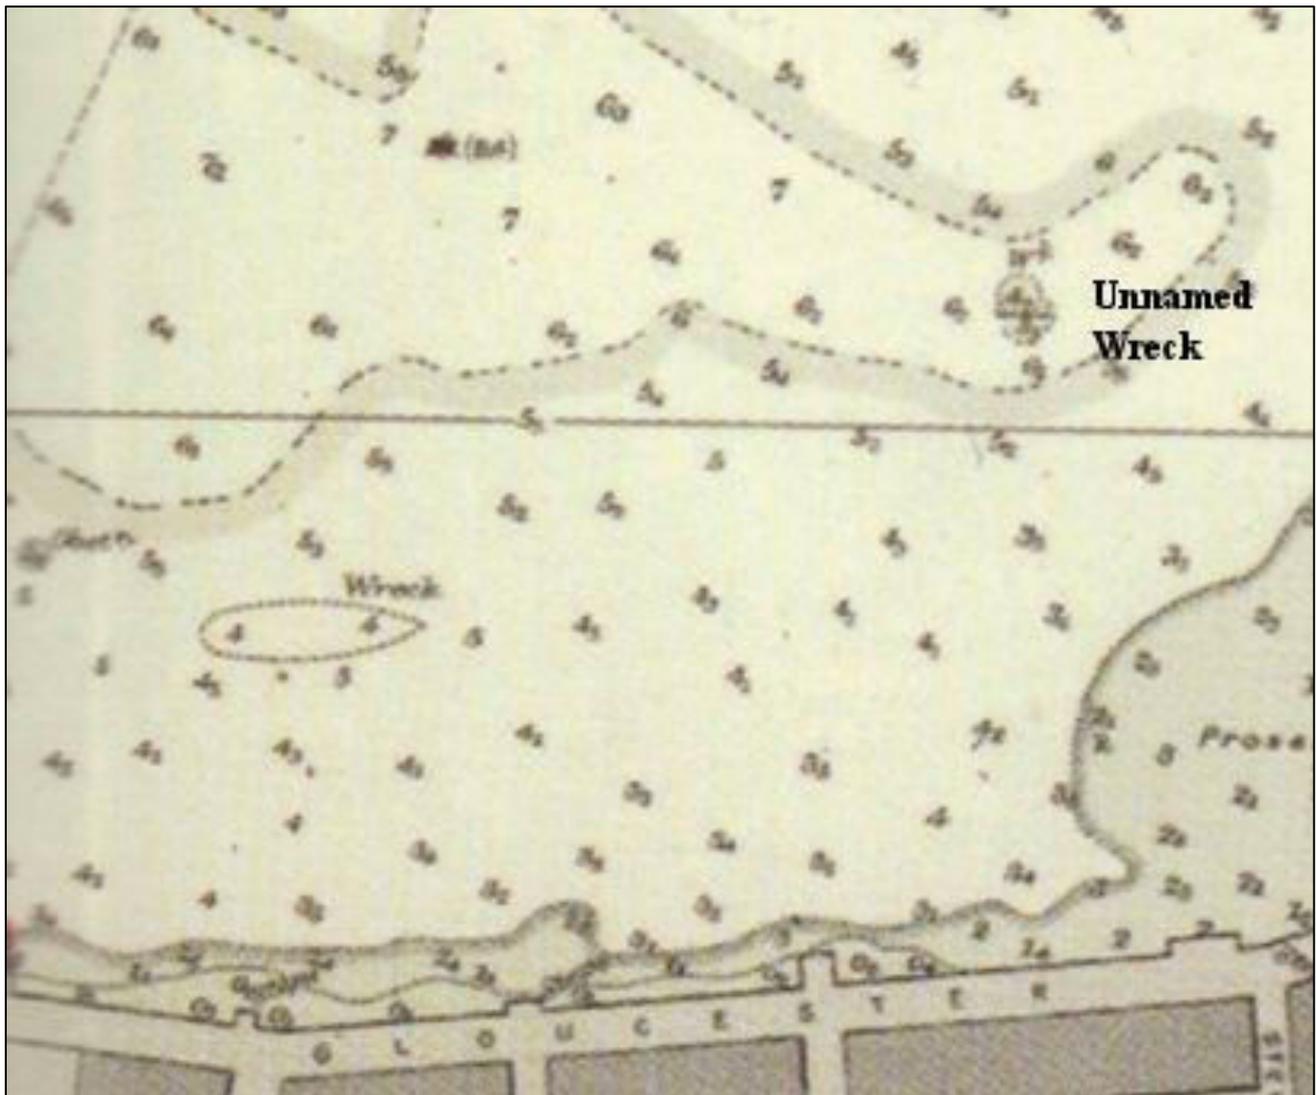
Figure 4a: Chart BA1459, *Hong Kong Harbour*, (1960 edition) still showing the *Halldor* marked “Wreck” and a much reduced—but unnamed—wreck outline (abbreviated to “Wk”) in the general area where the *Tamar* was charted in 1945. Nevertheless, this 1960 Chart did not contain further information to confirm unequivocally the unnamed wreck the remains of HMS *Tamar*.

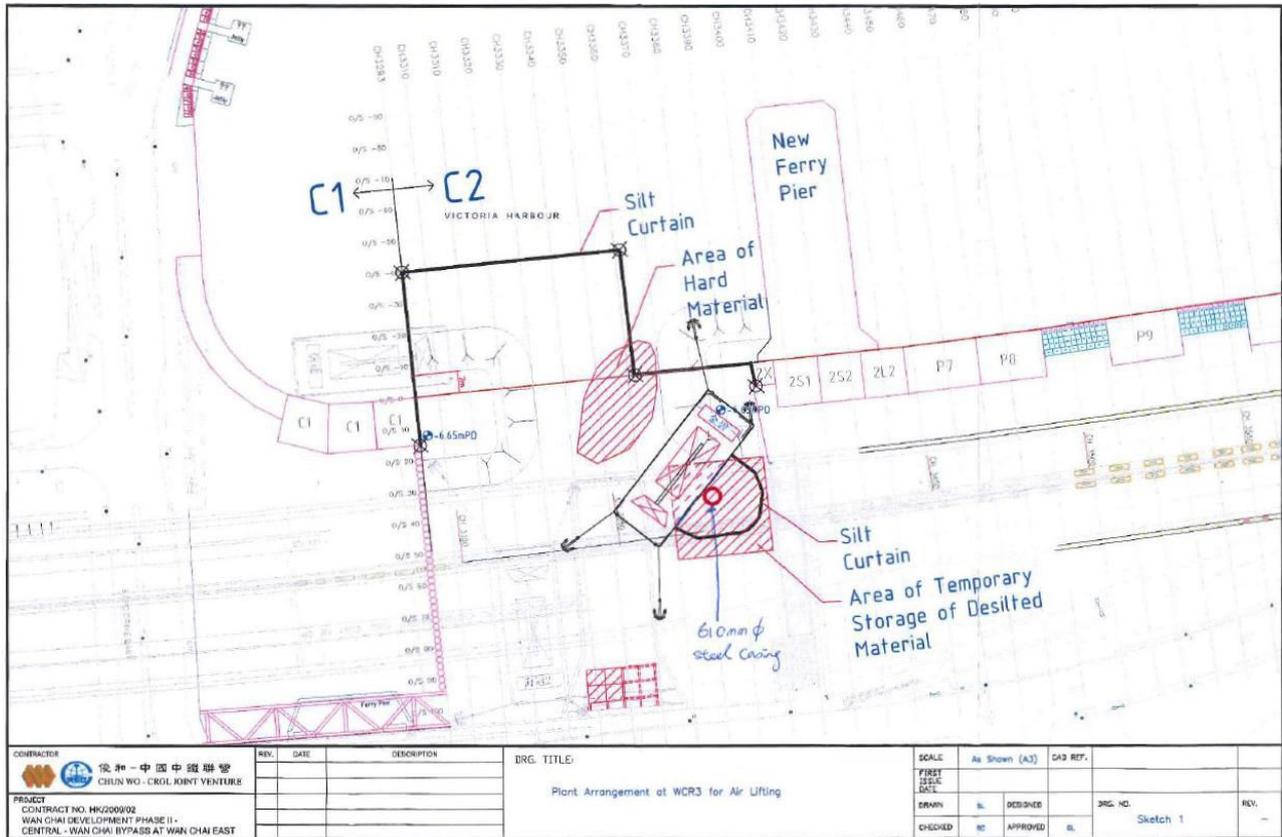
Figure 5: General arrangement for air lifting works on site (reproduced by kind permission of AECOM)

40m long by 11m wide—clearly the remains of large sunken ship—initially identified during recent dredging works immediately west of Wan Chai New Ferry Pier (Figure 5).

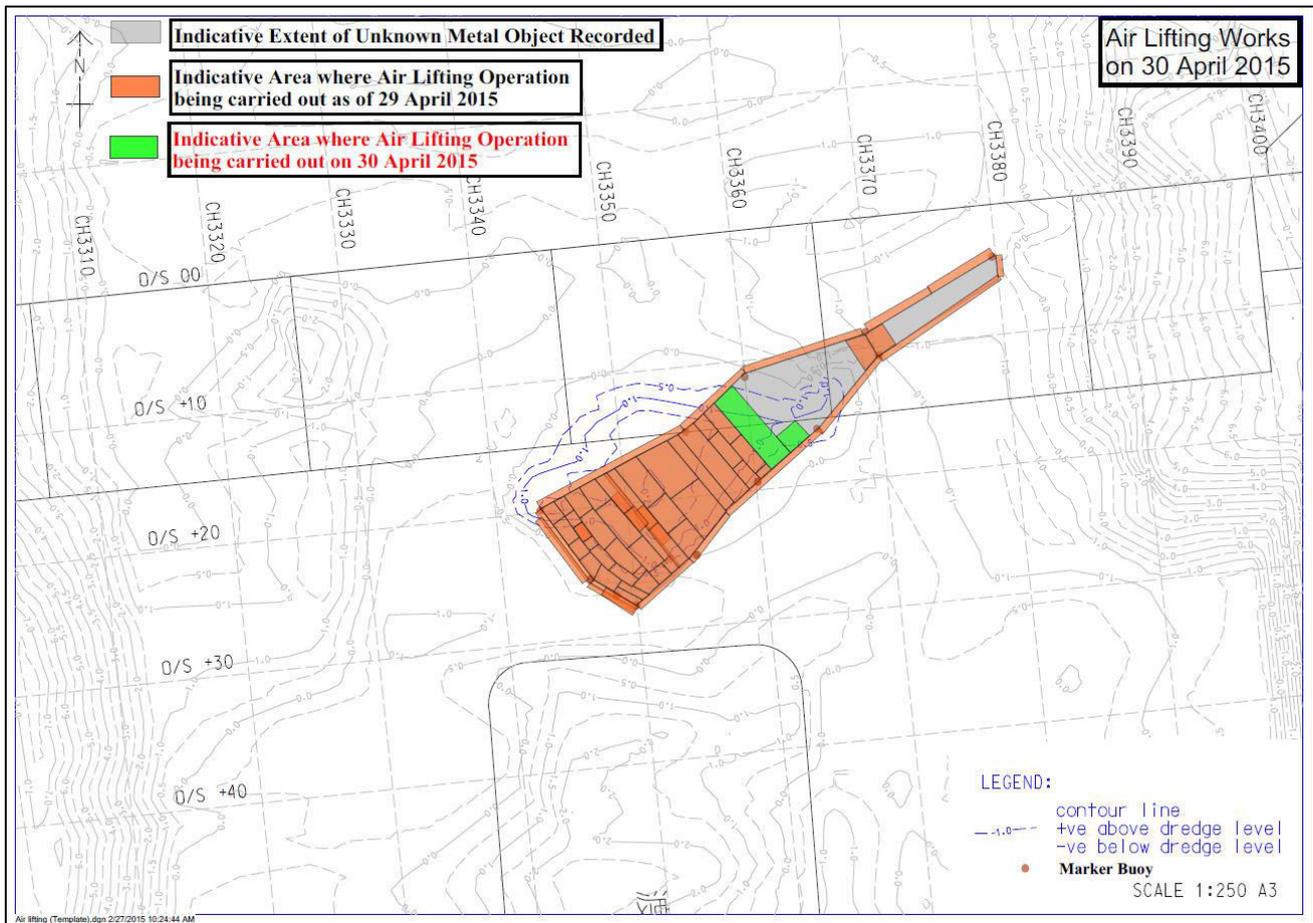
Figure 6: Plan showing air lifting progress as at 30th April 2015: orange = completed, green = ongoing and grey = still to do (reproduced by kind permission of AECOM)

During removal of up to 8m of marine sediment by dredger, to a level of -14mPD, eleven large fragments of riveted wrought ironwork were recovered, one with large wooden beams attached. Then since 25th December 2014 a team of divers has been working with an ‘air lift’ to systematically remove the remaining sediment from over the ‘bottle-shaped’ structure lying on the seabed at around -13 to -14m PD (Figure 6).

As Figure 6 shows, as at 30th April air lifting work had so far investigated the entire periphery of the site, fourteen linear transects across the width of the site, and a rectangular block at the north-eastern end. In the roughly 17 weeks of air lifting work so far conducted an estimated 60% of the total site area has thus far been investigated down the level of the hull or iron kentledge-concrete ballast.

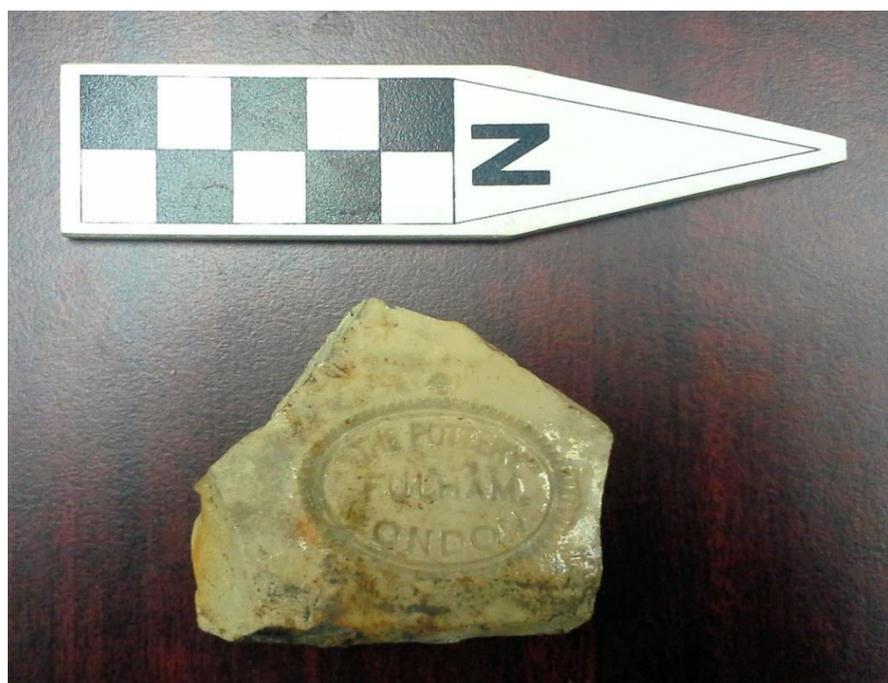
Figure 7.1: Item No.78: Fulham Pottery salt-glazed stoneware sherd

As yet pottery has been a relatively minor category of finds (5%), with a few fragments of thick-walled white or cream salt-glazed sherds probably from jars of tankards. The lower wall and base of one such item bears a very clear stamp of the “Fulham Pottery” (Figure 7.1), which operated in London until around 1928, although according to the Museum of London, salt-glazed stonewares were only rarely produced after 1918. Also present are a few sherds of glossy brown glazed stonewares of probable Guangdong manufacture, which are also a common feature of local terrestrial archaeological sites of late Qing-early 20th-century date. A white plate has on its underside an underglaze green stamp reading “EIRR H. Aynsley & Co. Ltd., 1957”.

There is a particularly significant clustering of manufactured objects made by companies that ceased production in the pre-Pacific War era, most notably: Item No.78 the 'Fulham Pot' (manufactured no later than 1928), Item No.155 the 'Gladwin Ltd., Fork' (manufactured no later than 1936); and Item No.393 the 'Keith & Blackman Co. Ltd., Fan' (made between 1900 and 1937). In addition there are several British military artefacts that can also be more closely dated to that same pre-war period, most notably Item No.1 'Goodman Name Plate' (1914-1915), Item No.132 'M.E. Co. Buckle' (stamped "1916"), Item No.170 the 'Royal Marines Light Infantry Button' (from a branch of the British Armed Services that ceased to exist in 1923), and Item No.520—another 'Royal Marines Button'—that can be dated from its manufacturer to between the 1840s and 1910.

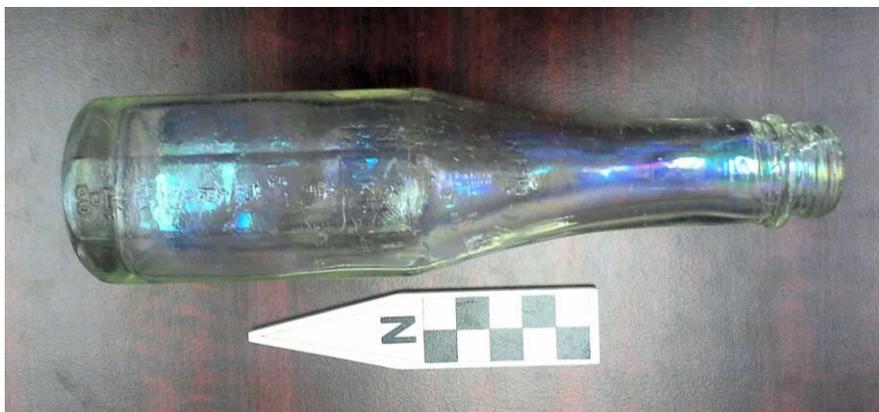
Figure 7.2a: Item No.156: Yu Kwen Yick Sauce bottle

Very few glass objects were noted but three bottles were recovered comprising an octagonal-shaped “Yu Kwen Yick” chilli sauce bottle, whose ‘oil-on-water’ colouration and presence of bubbles trapped in the glass may suggest a date early in the company’s 93-year history (Figure 7.2a), a 7-UP bottle probably manufactured in 1977(7.2b), and a Schweppes soda bottle.

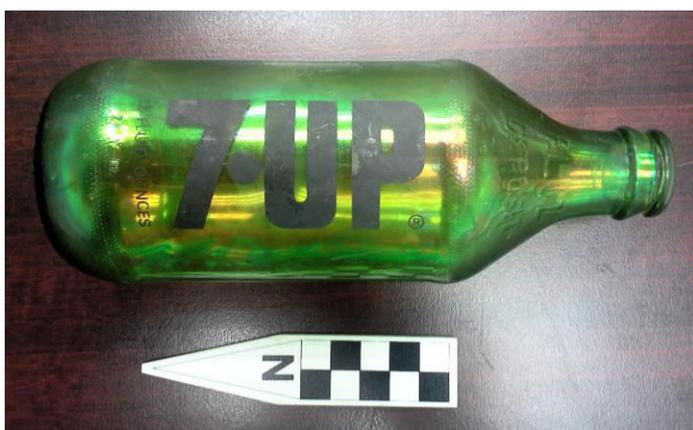
Figure 7.2b: Item No.37: 7-UP Bottle

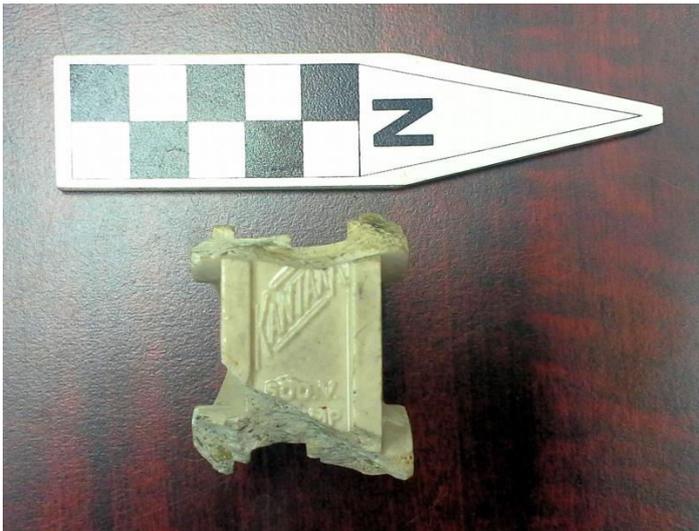
Figure 7.3: Item No.105: ‘Kantark’ Brand Ceramic 500V Electrical Insulator

The domestic component of the finds assemblage—in other words the items that reflect the day to day needs of the people who used the vessel at the centre of the investigation—is also reflected in finds of floor or wall tiles and various fragments of white or off-white sanitary wares of the types typically occurring in the bathrooms, shower areas and toilets one might expect to find on an accommodation vessel. A number ceramic insulator fragments were also recovered such as the ‘Kantark’ Brand example in Figure 7.3.

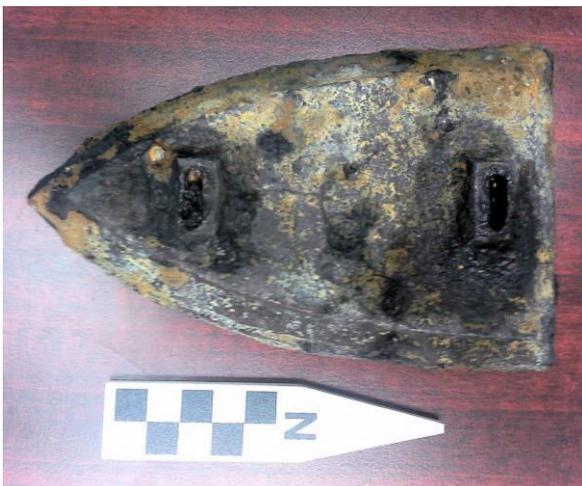
Figure 7.4: Item No.57: Cast Iron Flat Iron (for ironing clothes)

Altogether around 120 iron objects have been recovered, among which rivets provide the largest group followed by threaded fasteners in the form of screws and bolts. There are also a number of plate fragments—perhaps resulting from salvage works or earlier military impact—as well as a few undiagnostic ‘lumps’. Among the more interesting iron objects found was a well-preserved cast iron flat-iron (Figure 7.4), of a size most likely used for ironing clothes, and a lifting hook with forged eye still linked to a U-sectioned ring, which would originally have held a rope. Also found was a heavy duty door bolt and a rectangular solid block of iron ‘keyed ballast’ with a perforation through the middle.

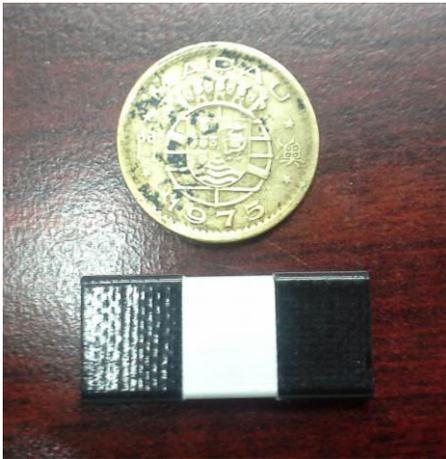
Figure 7.5a: Item No.159: Macau 10 Avos Coin dated 1975

Copper alloy artefacts—many apparently made from brass, although other copper alloys are probably present—are particularly well-preserved within the wreck site and account for around two-thirds of the items recovered. Particularly large quantities of screws, light switches and sockets, door furniture including doorknobs, hinges and locks, as well as a wide variety of ship’s fixtures and fittings are present. A copper alloy Macau 10 Avos coin dated 1975 was also found (Figure 7.5a).

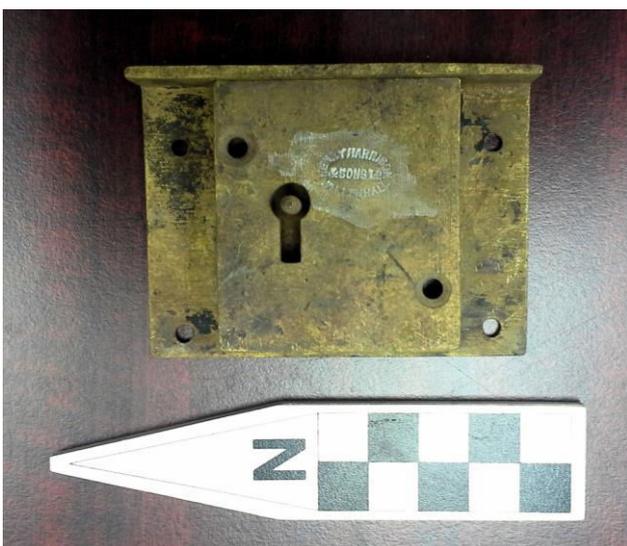
Figure 7.5b: Item No.95: Copper Alloy Lock bearing maker’s mark “Henry Harrison Ltd.”

A very well-preserved door hook and pad-eye was of the kind used to secure sliding doors or to tie back hinged doors in the open position. The purpose of a small copper alloy token bearing three stars at 120 degrees to one another and perhaps a bird in the centre requires further research. A stamped brass ashtray has no obvious markings but is in a standard Royal Navy pattern. A circular electrical light switch with stepped profile has the appearance of something originally used in a quite smart accommodation area of the vessel, perhaps a wardroom or mess. The remains of several brass door locks are present, including one lock plate bearing a clear “British Made” stamp and another with the British maker’s mark “Henry Harrison Ltd” (Figure 7.5b).

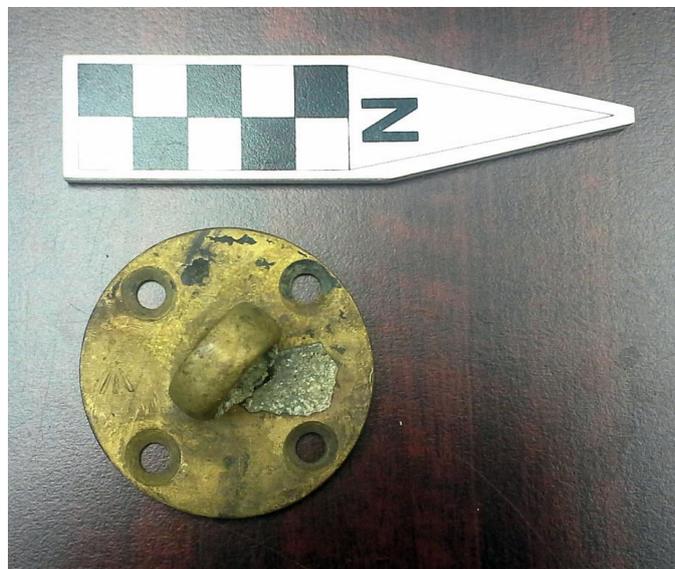
Figure 7.6: Item No.14: Copper Alloy Pad-Eye with War Department Arrow stamp (left centre)

Another brass plate—probably also from a lock—carries the distinctive War Department broad arrow stamp used to identify items as British military property, which is a mark that also appears on a door-hook, screws, brackets, and a brass pad-eye (Figure 7.6).

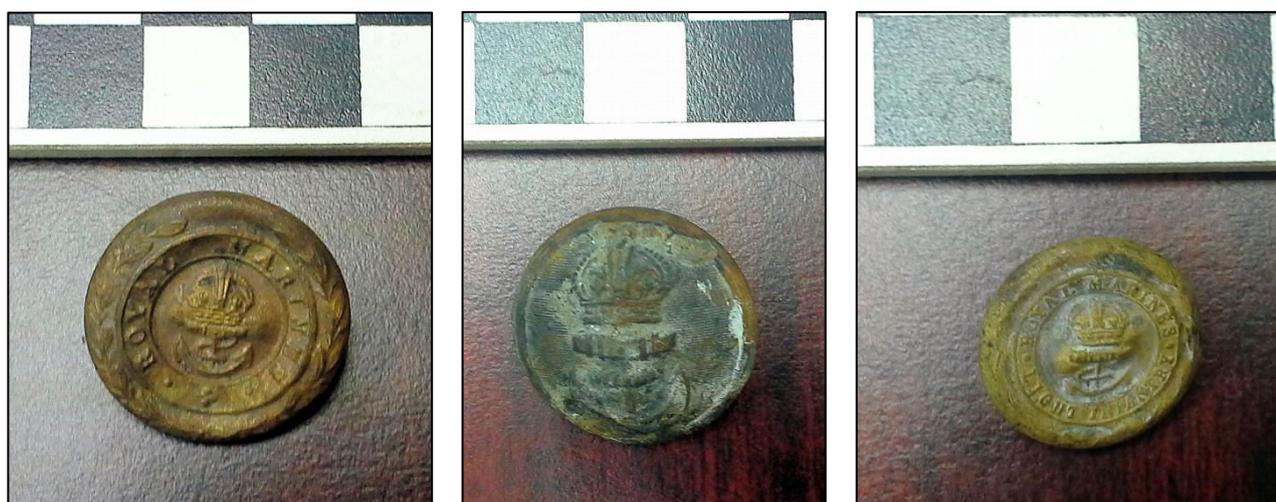
Figure 7.7a, 7.7b & 7.7c: Buttons (left to right): Item No.277: Royal Marines; Item No.171: Royal Navy; Item No.170: Royal Marines Light Infantry

The same stamp is also on a large copper alloy and lead fire hose nozzle found during the project. Several stamped plates—probably from doors or covers—were recovered including the following: a rectangular plate stamped “Steam to Derrick Engine”; a long rectangular brass ‘tag’ with the words “Lantern Store”, and a small example stamped “Entrance Door No.=2 Cabin”. One item with an obvious military connection was a bullet, although the calibre could not be accurately checked prior to its removal for checking by the police. A brass Royal Marines cap badge and six brass buttons have been found including examples identified as being from the uniforms of members of the Royal Marines, Royal Navy and Royal Marines Light Infantry (Figures 7.7a, 7.7b & 7.7c respectively).

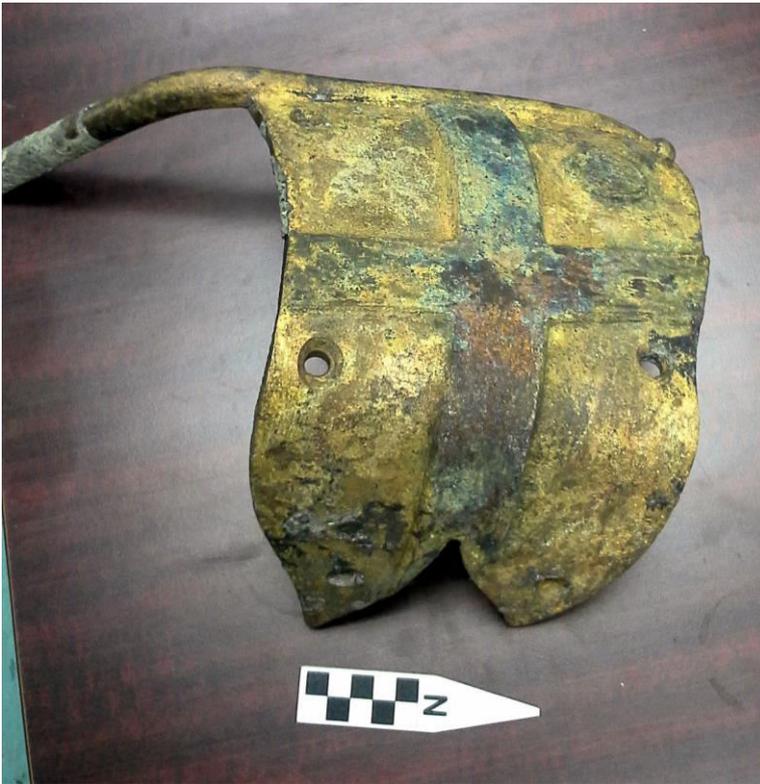
Figure 7.8: Item No.172: A Royal Navy Commodore's Pennant (flag)

One of the most significant discoveries is a copper alloy replica of a Royal Navy Commodore's pennant (flag) (Figure 7.8). The five fixing holes suggest it was originally bolted or screwed onto the ship or perhaps more likely one of the smaller launches it carried. The Hong Kong naval base was historically under the command of a commodore—for example in 1934 Commodore Frank Elliot R.N. was the man in charge—whose headquarters and flagship until the Pacific War was HMS *Tamar* (Greystone nd.). This object is therefore a highly significant find.

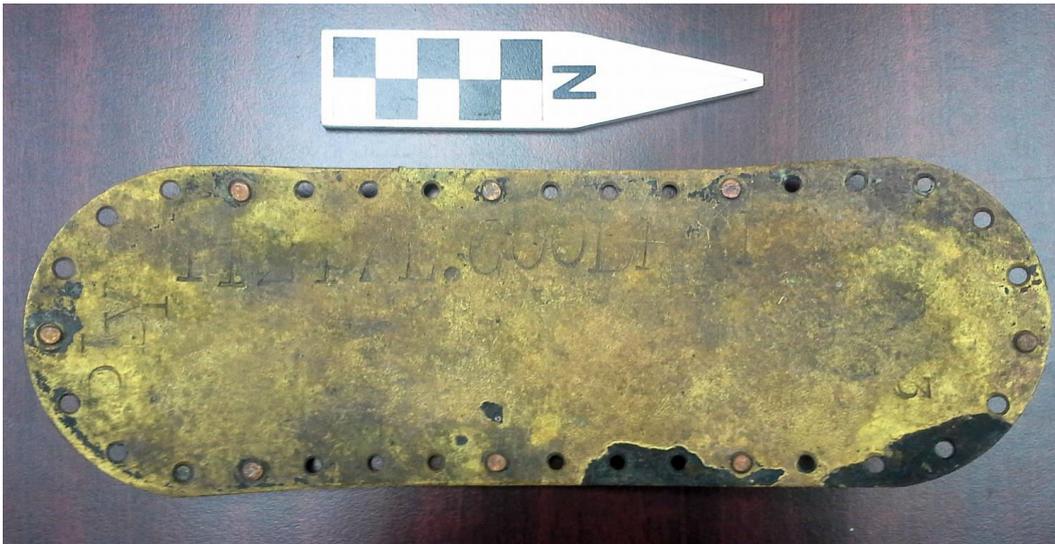
Name Plate or 'Tingle'

Figure 7.9: Item No.1: Name Plate of Royal Marine Light Infantryman Edgar Charles Goodman

Another highly significant find, which, due to it bearing the name and service number of a particular Royal Marine, can be firmly placed in an early 20th-century British naval context in Hong Kong, is a name plate or 'tingle' (Figure 7.9). This is a 22cm long by 7.6cm wide oval plate made of 4mm sheet, which has copper rivets suggesting it was originally attached to a 3mm thick substrate of perhaps leather or canvas, perhaps a trunk or case of some sort. It bears the following inscription reading clockwise from the left-hand side: "PLY 11217 E Goodman 7.13". Research in the British National Archives (file reference ADM159/79) revealed that the service number 11217 belonged to Edgar Charles Goodman, who enlisted in the Plymouth Division of the Royal Marine Light Infantry on 22nd October 1901.

From his service record Corporal Goodman reached Hong Kong during 1914, where between March and August he served on a gunboat named HMS *Thistle*. However, in August the crew of the *Thistle* was transferred to HMS *Triumph*, which was then in dry dock in Kowloon undergoing a refit in readiness for active service in WWI. At that time Hong Kong's naval base had no land-based barracks and *Tamar* served as both the Navy's administrative HQ and its barracks (accommodation for Royal Marines and Naval servicemen based in Hong Kong or whose ships were undergoing refit or repairs in dry-dock). For naval personnel—including Royal Marines—who were transferred off one ship but unable to join their new vessel due to it being in dock, the normal routine would involve their being temporarily accommodated with their kit in the local depot or accommodation ship, which in Hong Kong was HMS *Tamar*. At present there is no historical record confirming Goodman's presence on board *Tamar*, but if normal naval protocols were followed, it seems probable that he and his kit spent some time on *Tamar* before *Triumph's* eventual departure from Hong Kong to join the Gallipoli campaign on 12th January 1915. In May 1915 *Triumph* was sunk off Gallipoli but Goodman survived the war to eventually retire on 21st October 1922, aged 39.
